Manhole Inspection Summary

Manhole # S13II_026MH

Insp Date: **2/24/09 9:50 AM**

Location Address: **1901 DUKELAND ST**

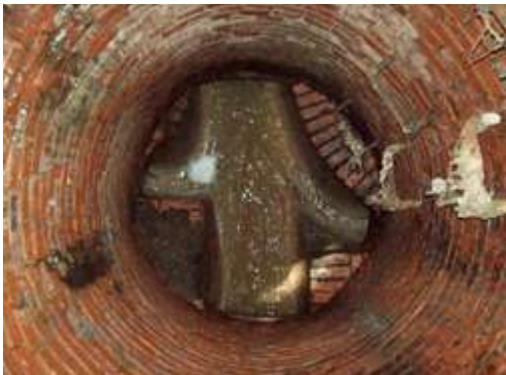
Defect 1

Count: **21** Missing: **0** ☒ **Corroded**

☒ **Evidence Of Surcharge** Depth: **12** (ft.) ☐ Active Surcharge Present

EVIDENCE OF SURCHARGE AND
CORRODED STEPS

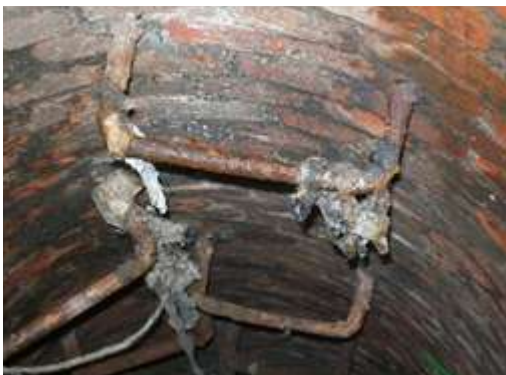
Defect 2

CORRODED STEP

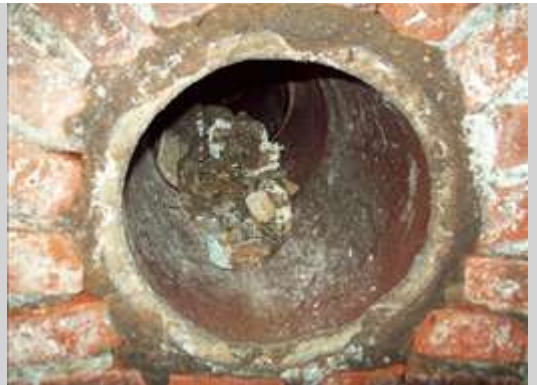
9 O'Clock Inflow

Deposits: ☐ None ☐ Mud ☐ Sludge ☒ **Debris** ☐ Grease

Silt Depth: **2** (in.) Deposits Extent: **Light**

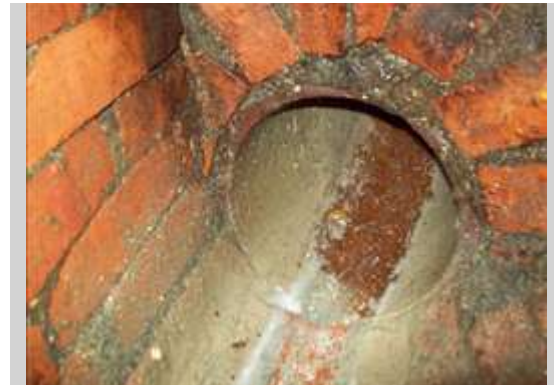
Drop In @ 9 O'Clock

Drop Condition: **Partly Clogged**
